FACILITY COMPLIANCE INSPECTION REPORT

Division of Waste Management Solid Waste Section

Date of Site Inspection: November 3, 2011 **Date of Last Inspection:** August 21, 2008

Apple's LCID Landfill
Elon-Ossipee Road
Elon, NC 27244

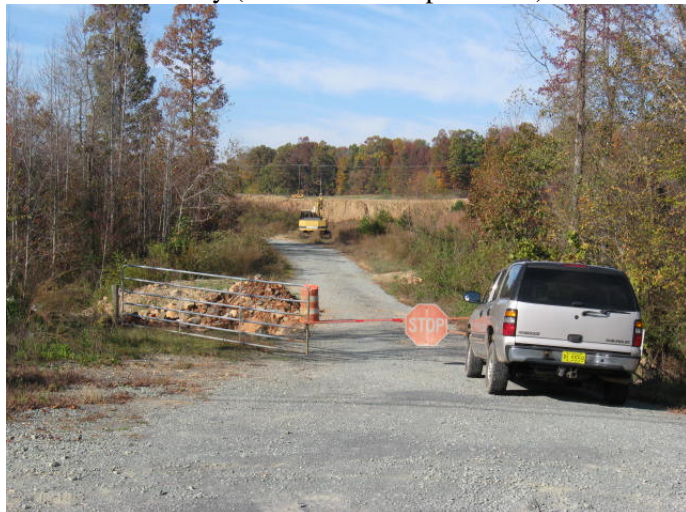
Entrance to facility (from Elon-Ossipee Road)

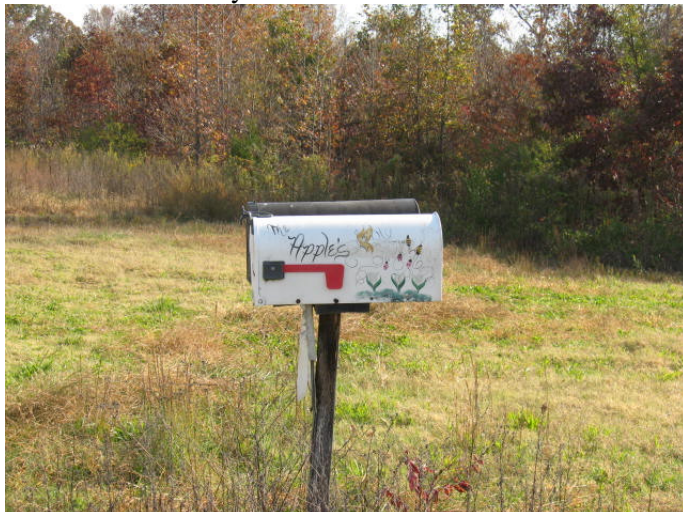
9. There was no indication of erosion or runoff.
10. The facility is secured by a locked gate.
11. Access roads are of all-weather construction.
12. There is a mailbox, located along the service road to the landfill area, containing tickets for haulers to fill-out.

Mailbox on facility service road w/hauler tickets

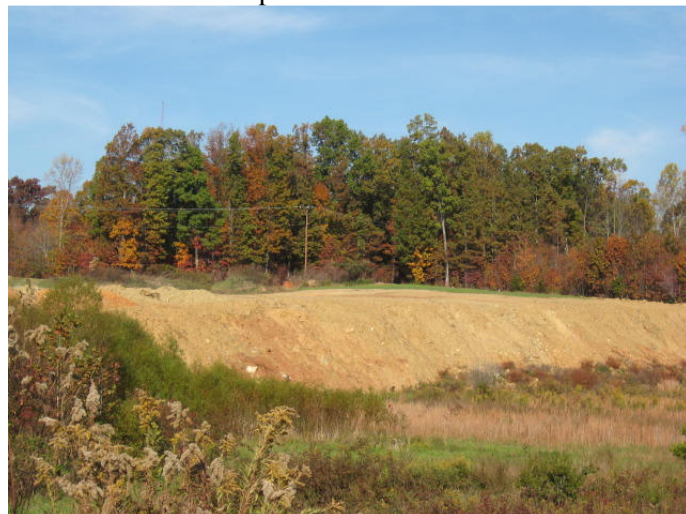
LCID landfill side slope

5. Side slopes should be graded and covered with soil such that a 3:1 slope ratio is obtained or a ratio of which no indication of erosion or runoff is observed.

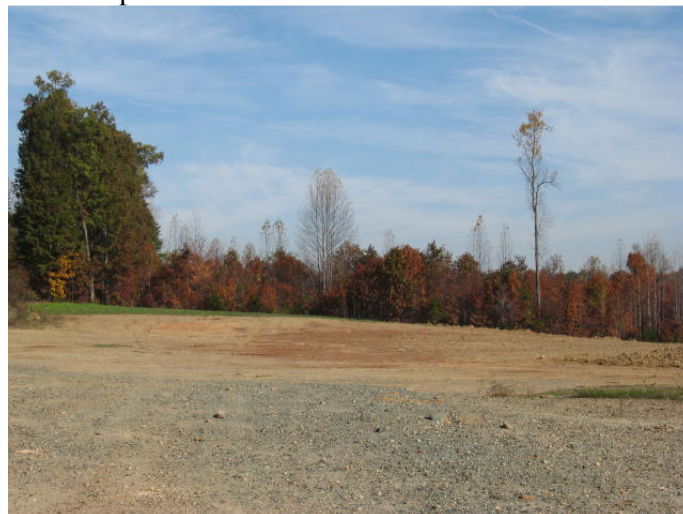
Area atop LCID landfill

6. Ensure that water does not pool atop landfill area.
7. Land clearing debris was adequately covered with soil.
8. Ensure vegetative material is established as ground cover.
